CIA/PIR-67129

CIA IMAGERY ANALYSIS DIVISION

HUANG-PU SHIPYARD
KUANG-CHOU, CHINA

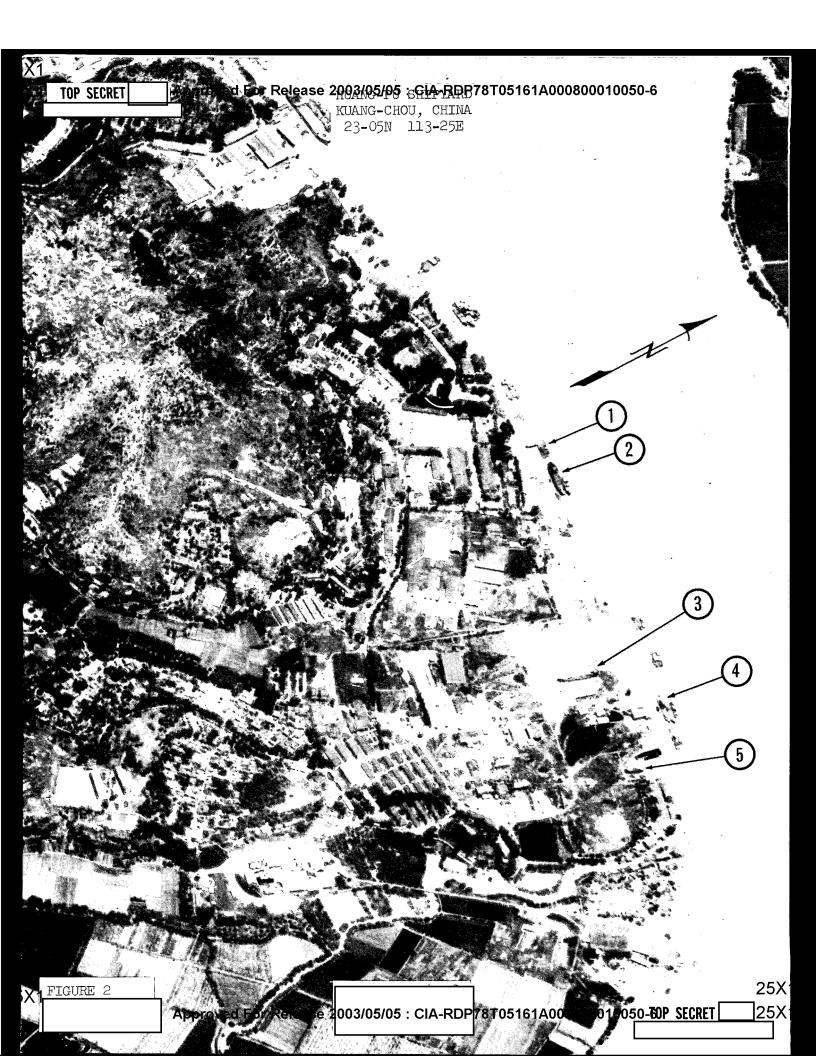
1	Approved For Release 2003/05/05/05/05/05/05/05/05/05/05/05/05/05/
	CIA/PIR-67129
	CIA IMAGERY ANALYSIS DIVISION
•	SHIPYARD: HUANG-PU SHIPYARD LOCATION: KUANG-CHOU, CHINA GEO COORDS: 23-05N 113-25E
	KEY TO ANNOTATIONS ON FIGURE 2
	1. Two possible "P-6" Class PT alongside quay.
	2. Probable British "LCT-3" Class LCU alongside quay.
	3. Unidentified landing craft on building/repair way. See annotation 4 on Figure 2,
[·	4. Probable KRONSHTADT Class PC alongside quay. See annotation 3 on Figure 2,
1	5. Possible "P-6" Class PT hull on building/repair way. See annotation l on Figure 2,

Reliable mensural data could not be obtained due to the obliquity of

the photography.
